# Railroad accident investigation report

Report No. 79-9

LOUISVILLE AND NASHVILLE RAILROAD COMPANY

CRESTVIEW, FLORIDA

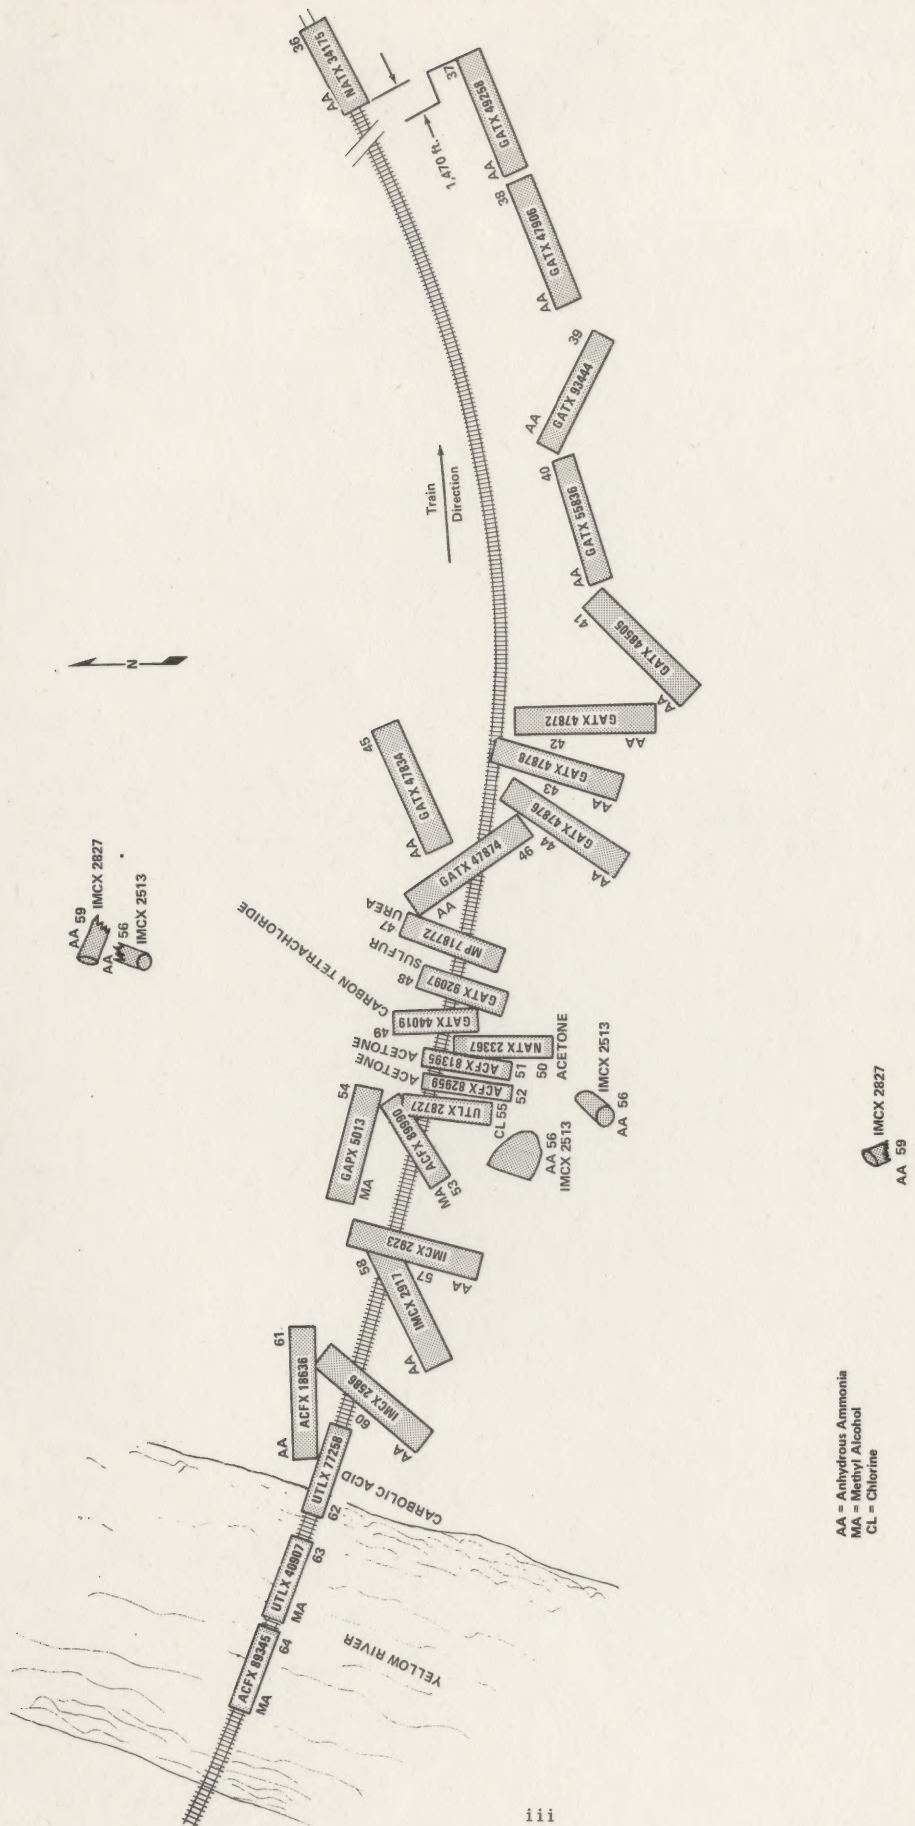
# PLAN VIEW OF ACCIDENT SITE

The derailment occurred as the train entered a 4° curve and longitudinal forces built up in the area of the 36th to the 40th car. These longitudinal forces accentuated the lateral forces already present because of track curvature and speed. One of these cars derailed as a result of the high lateral forces and disturbed the track sufficiently to derail the following cars. Twenty-five of these cars were placarded tank cars containing hazardous materials. The severity of the accident was greatly magnified due to the types and amounts of hazardous materials contained in the train.

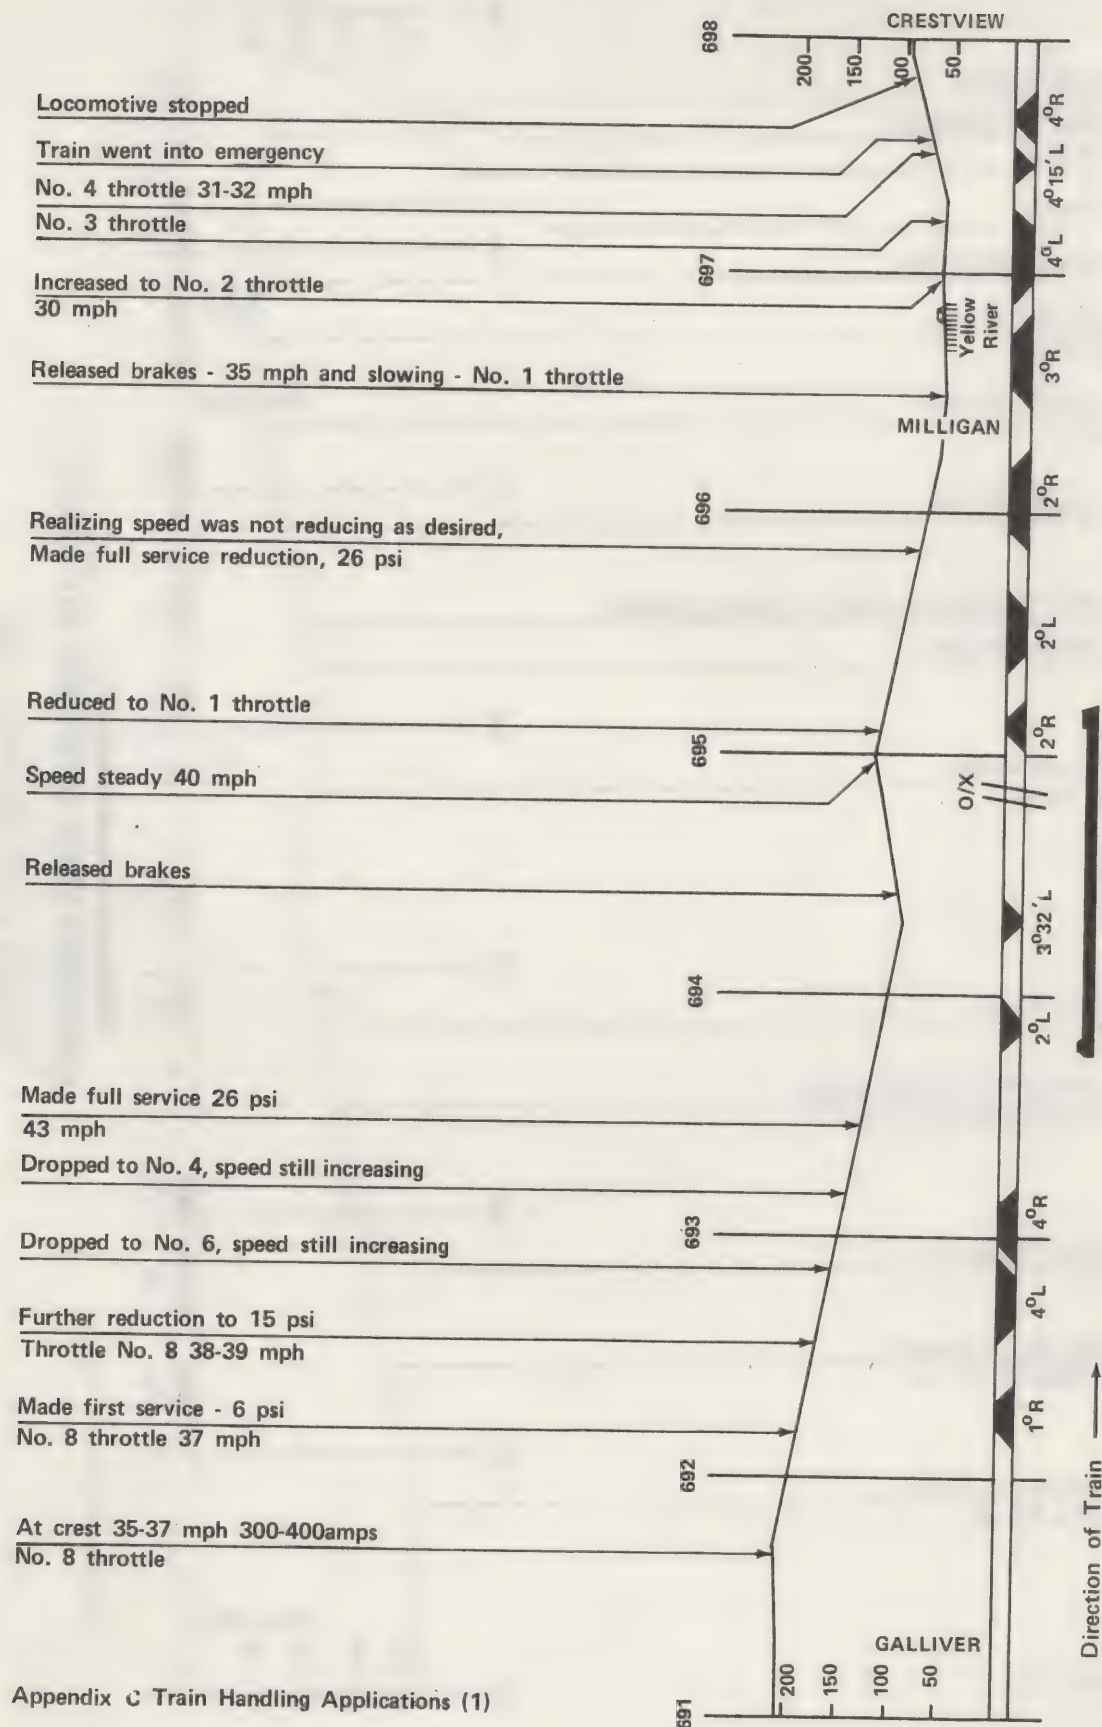
Appendix C (2)

Locomotive stopped

Train went into emergency
